A NANOLIME CASE STUDY

The City of London Cemetery entrance screen

Ben Newman

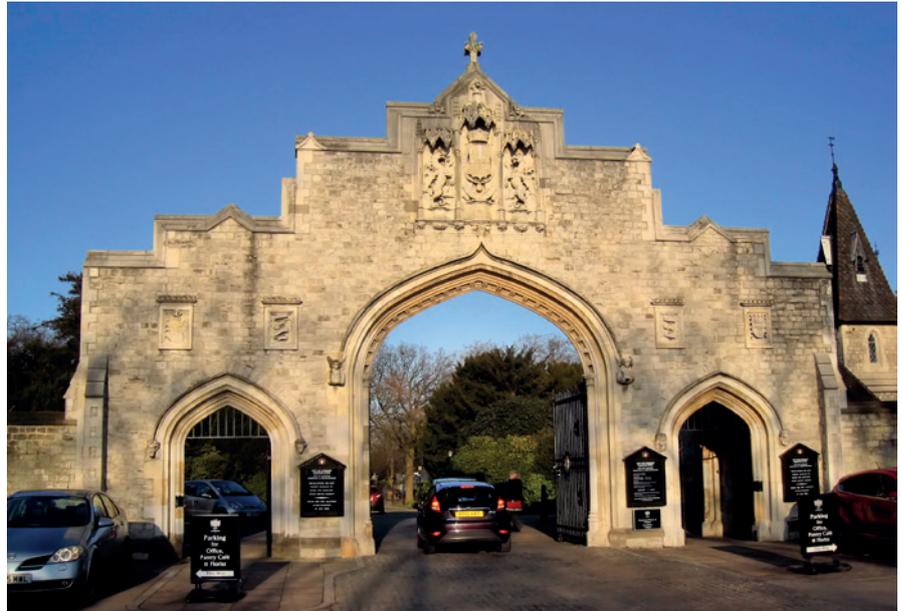
The City of London Cemetery screen before the project: the use of impermeable cement repairs had increased the rate of decay to the point that the stonework had become unsafe. The central shield in particular was perilously close to becoming detached.

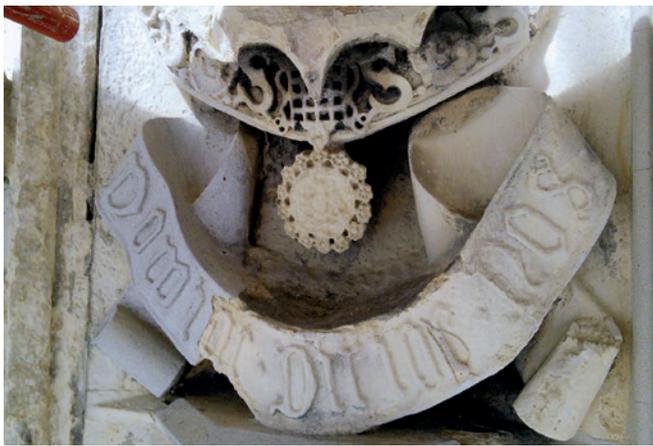
The bottom of the crest before work: note the cementitious repair (left) and adjacent erosion.

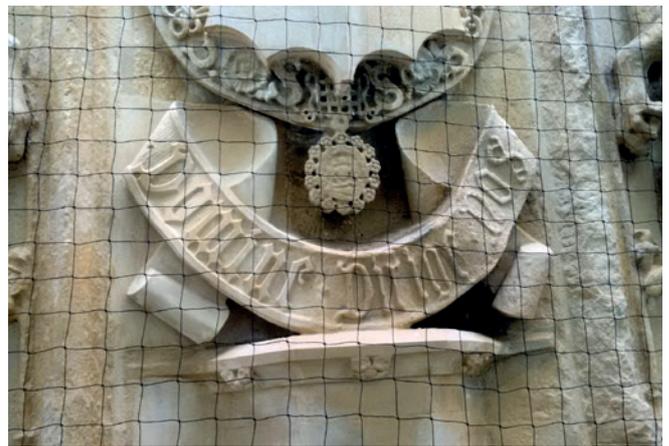
The bottom of the crest completed: note the retained original fine carved medallion and the new shield above it. The friable areas of stone were first consolidated with nanolime, then mortar repaired and limewashed.

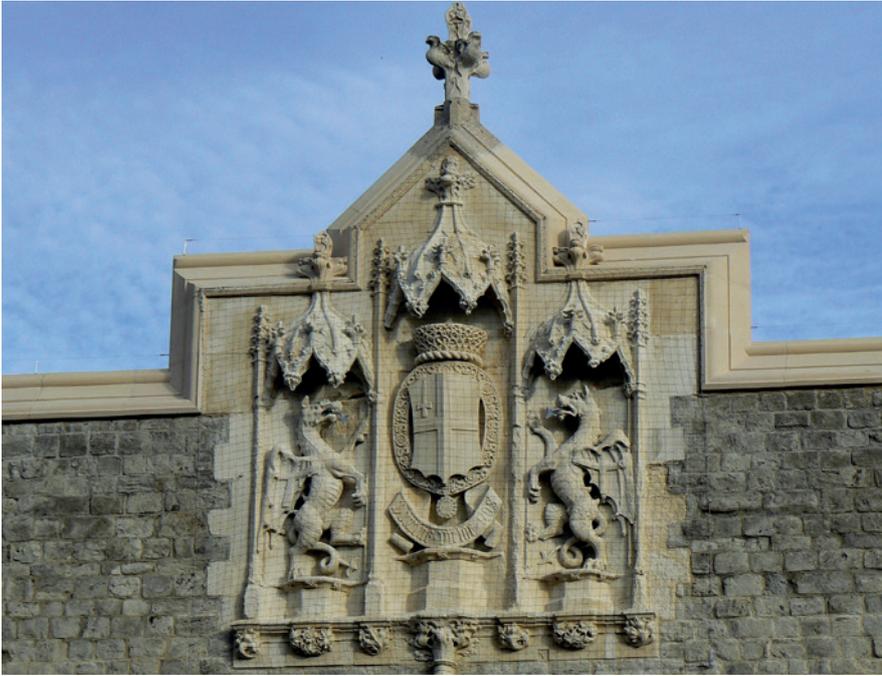
The central crest after consolidation and repair: note the new stone shield, Muscovy hat, copings and foliate corbels with nanolime consolidation and limewash.

- 4 Stone elements which were at risk of falling because of their overhanging position were replaced like-for-like in Caen stone. Two such stones were the shield bearing the city crest and the Muscovy hat, both of which had multiple fractures and were at considerable risk of detachment.

Once the repairs were completed, the whole area was given five coats of specially colour-blended, casein-bound limewash to unite the central panel. This also helped to cover any white bloom from the nanolime and will further protect the fragile nature of the carved work.

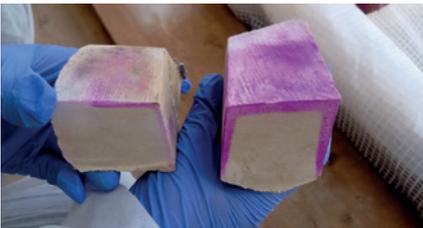
The depth of penetration of the nanolime was gauged with the use of phenolphthalein, which turns pink in the presence of un-carbonated lime. The sample of stone treated with the nanolime was cut in half and sprayed with the indicator: the depth of penetration is clearly seen.

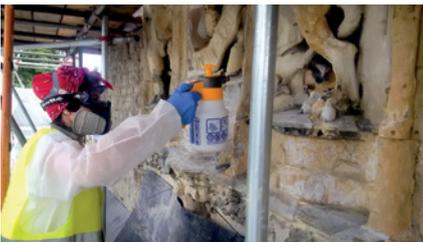
Nanolime was applied with a pressurised garden spray and the area was covered in cling-film between applications to delay evaporation of the ethanol and promote maximum penetration.
